FINAL
Coal Ash Impoundment –
Specific Site Assessment Report
PPL Montana
Colstrip Power Plant

Submitted to:
Lockheed-Martin Corporation
2890 Wood Bridge Avenue
Building 209 BAYF
Edison, NJ 08837

Submitted by:
GEI Consultants, Inc.
6950 South Potomac Street, Suite 300
Centennial, CO 80112

September 2009
Project 091330

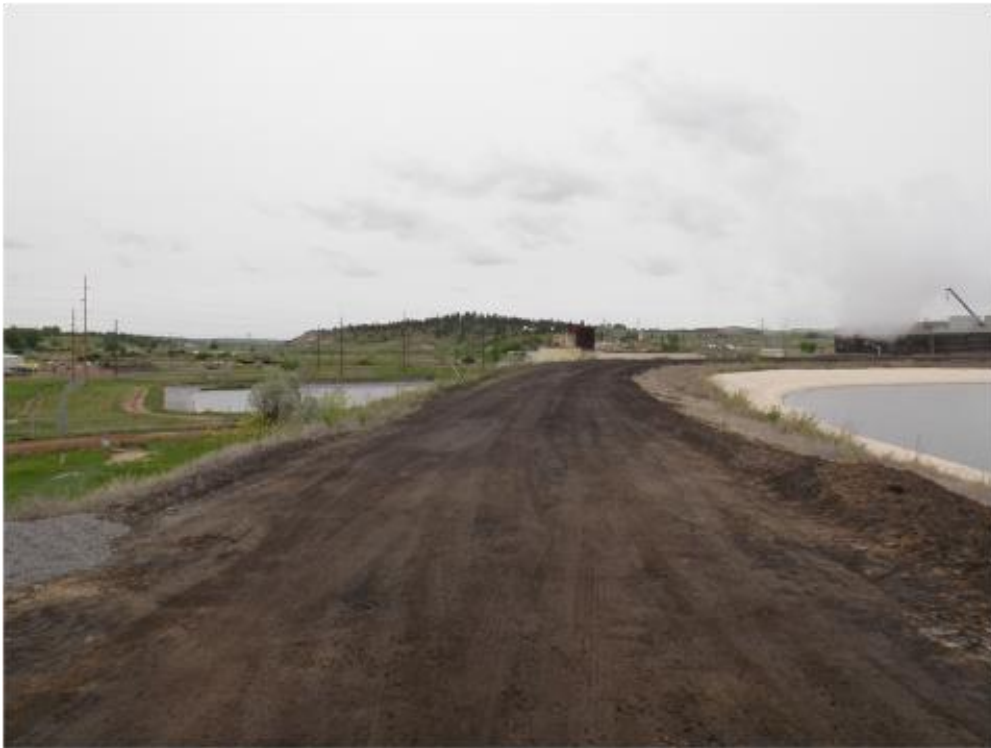
The embankment crest appeared to be in good condition. No signs of cracking or settlement were observed during the assessment. No vegetation was present on the dam crest. (Photos 3 and 4).

Photo 3: Units 1 & 2 Bottom Ash Ponds: west cell, looking north at crest of west embankment. Note RFP lining on upstream slope.

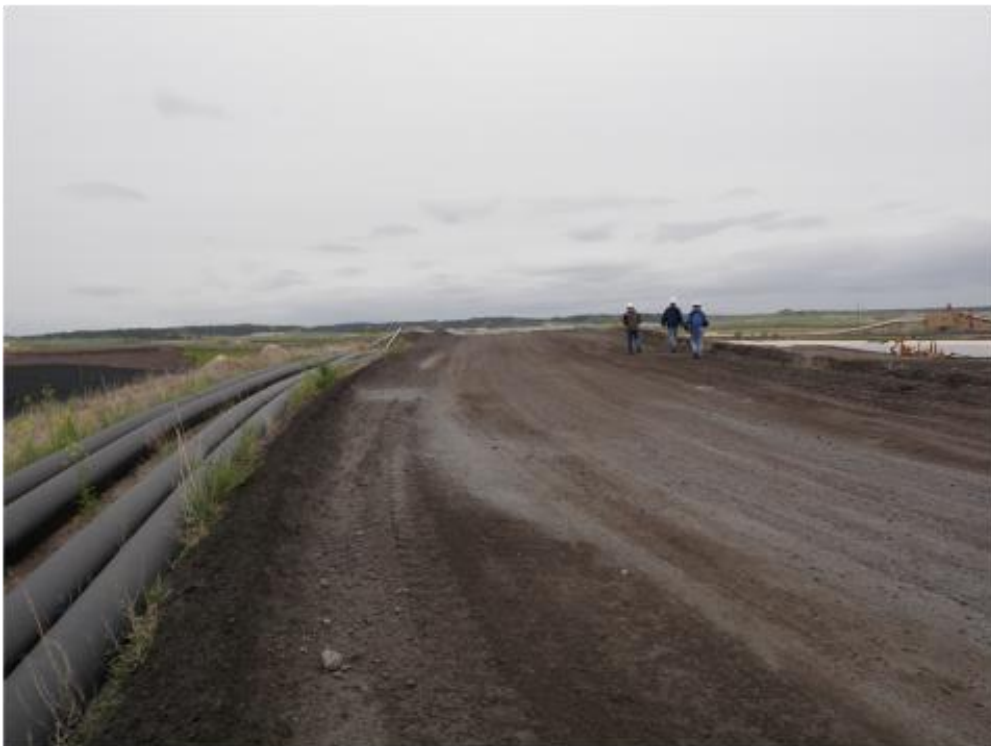
Photo 4: Units 1 & 2 Bottom Ash Ponds: east cell, looking south at crest of east embankment.

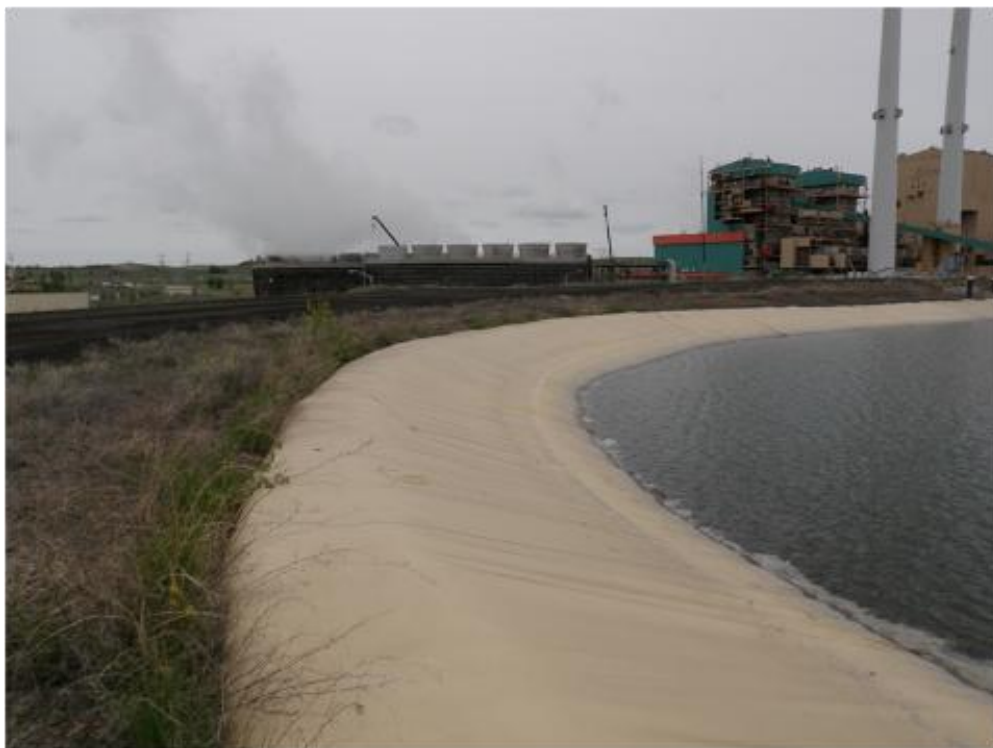
The upstream slope of the bottom ash pond embankment is protected from erosion by an RFP liner (west cell – Photo 5) and a clay liner (east cell – Photo 6) and appeared to be in good condition. A concern with regard to the upstream slope was a 24-inch HDPE pipe that protrudes from the interior southwest corner of the west cell of the bottom ash ponds (Photo 7). This pipe serves as a carrier pipe for two smaller 4-inch discharge pipes. The carrier pipe terminates in the interior of the embankment and provides a direct seepage path to the interior of the dam should the pond water level rise above the invert of the pipe. Measures should be taken to seal off the carrier pipe. PPL Montana has indicated the carrier pipe may not be needed for much longer and can be modified or removed.

Photo 5: Units 1 & 2 Bottom Ash Ponds: west cell, looking northwest corner of pond upstream slope.

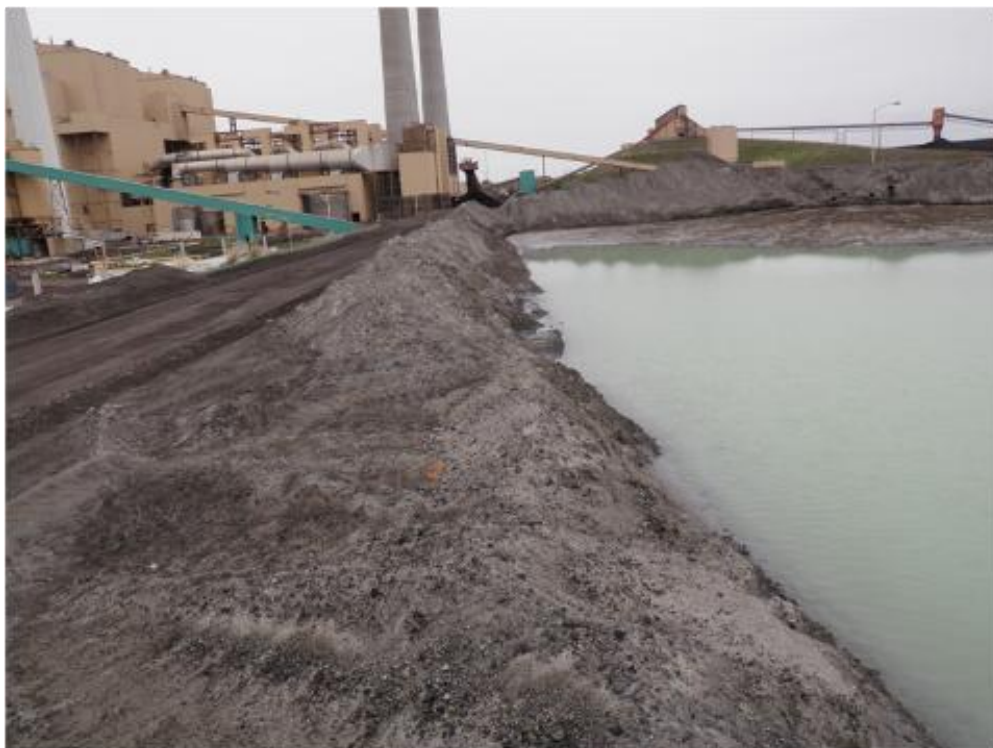
Photo 6: Units 1 & 2 Bottom Ash Ponds: east cell, looking east along upstream slope.
Note fly ash pushed up against the upstream slope.

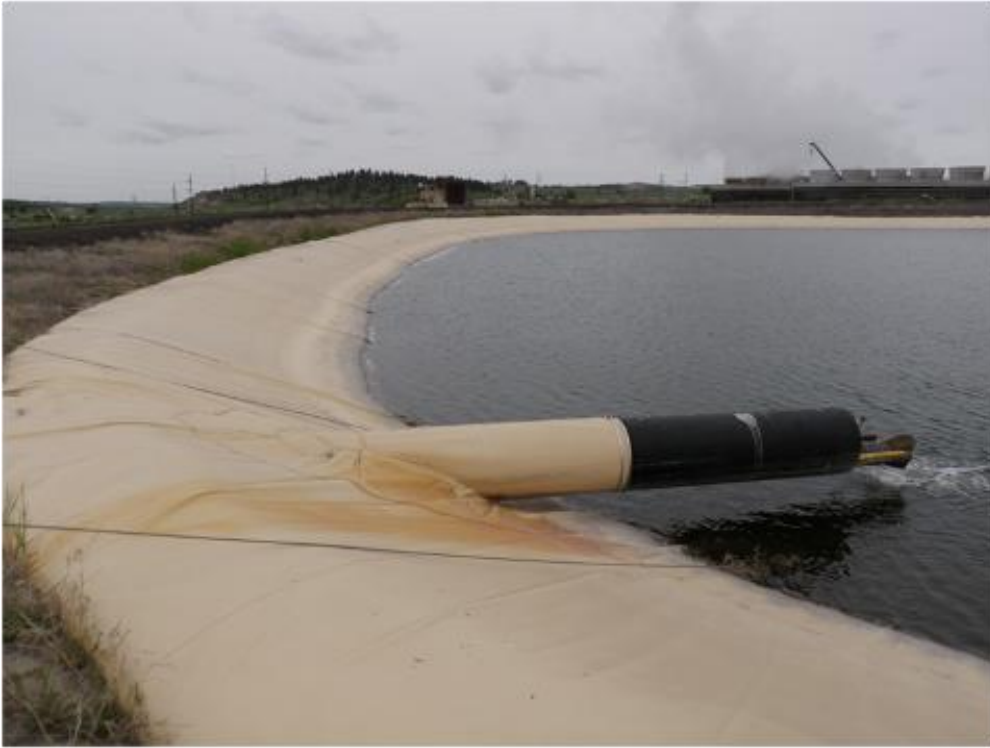
Photo 7: Units 1 & 2 Bottom Ash Ponds: looking north at carrier pipe penetration of RFP lining near southwest corner of pond and upstream slope. Note carrier pipe end is not sealed and would allow seepage directly to embankment at higher pond levels.

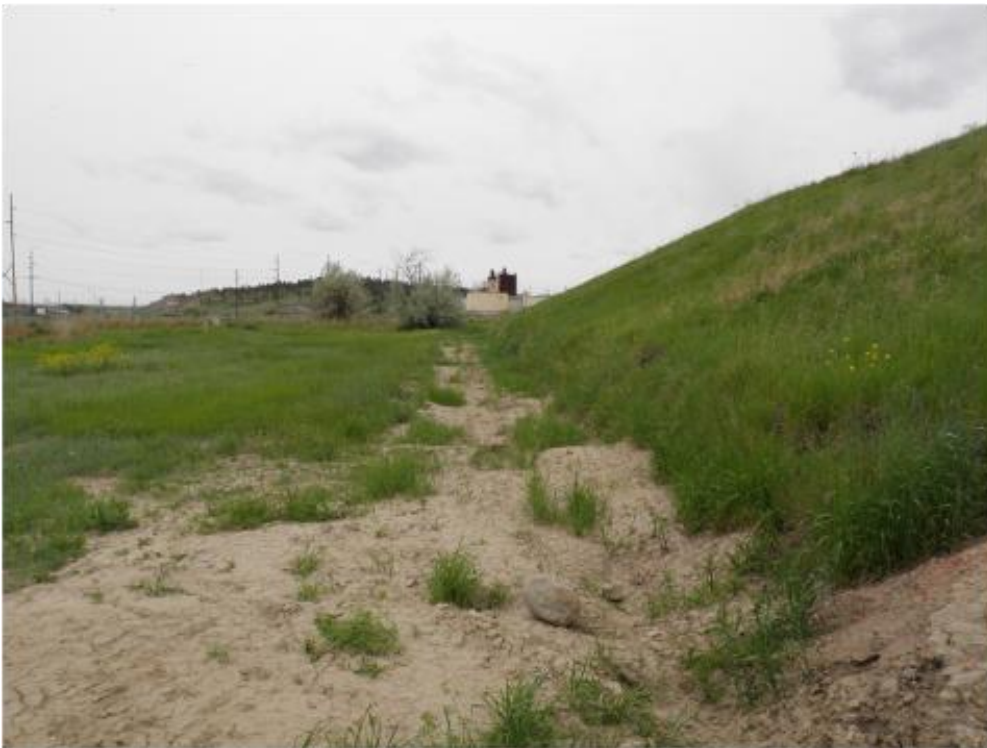
The downstream slope of the embankment is well-vegetated with grass, which provides some erosion protection (Photo 8), with the exception of the west side which is located in a coal storage area. No signs of major instability were observed along the downstream slope, though some oversteepened areas and rodent holes were observed along the toe on the west side of the embankment (Photos 9 and 10). The oversteepened toe appears to be caused by a cut made to establish a valley drain pipe easement adjacent to the toe of the slope. In addition, numerous elongated sinkholes (up to 1 foot wide, 2 feet long and about 6 inches deep) were observed in this area (Photo 11). PPL Montana personnel indicated the sinkholes were associated with the valley drain pipe alignment at the toe that was placed about 5 feet deep. The pipe was placed in the winter and backfilled in freezing temperatures, suggesting that the sinkholes likely occurred because of volume changes in the thawing backfill material. There is an out-of-service steel manhole associated with a cooling water pipe present at the northwest corner of the downstream toe (Photo 12). The manhole is on the order of 20 feet deep and presents a potential seepage pathway.

Photo 8: Units 1 & 2 Bottom Ash Ponds: east cell, looking north along downstream toe from near the southwest corner of east cell. Note disturbed soil at toe along recent pipe trench.

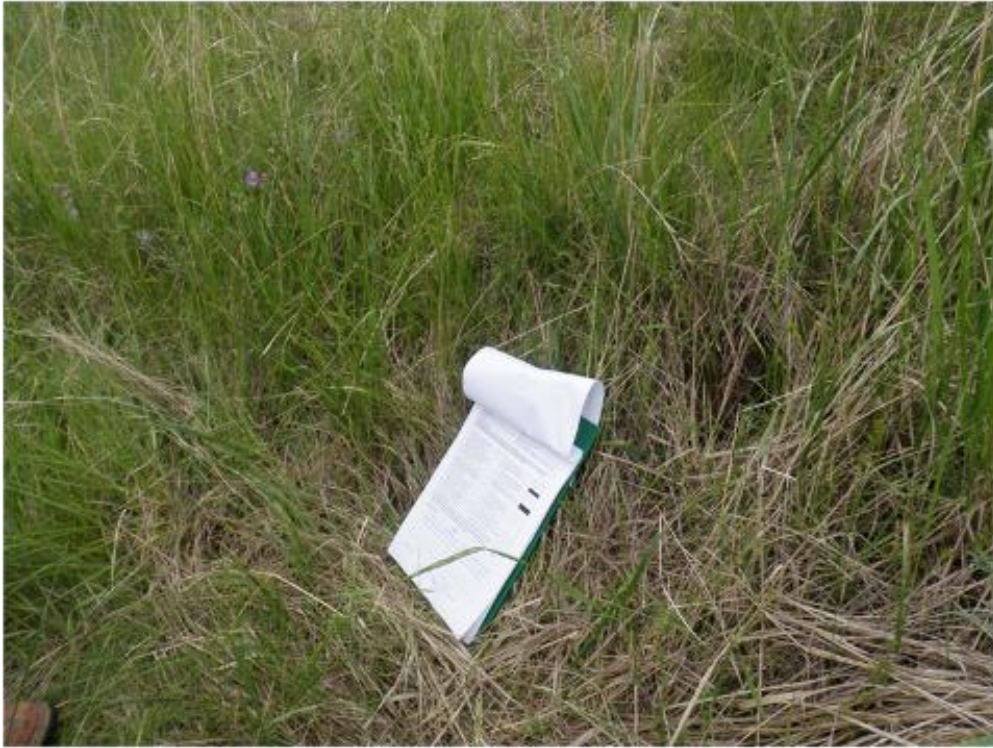
Photo 9: Units 1 & 2 Bottom Ash Ponds: west cell, rodent holes in downstream slope near northwest corner of west cell.

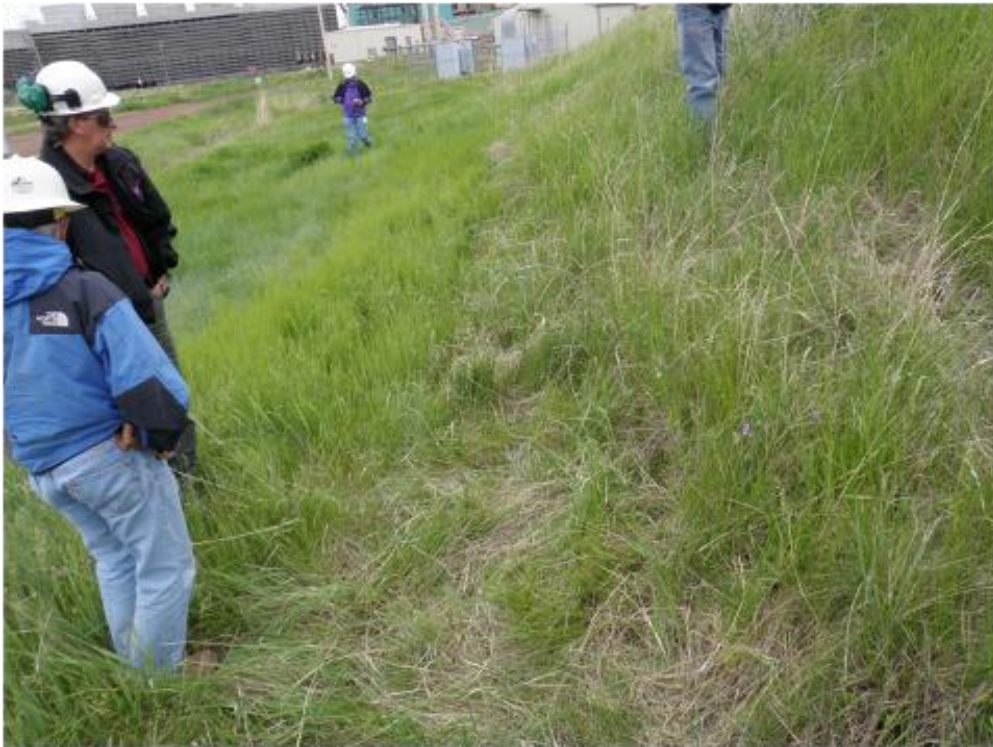
Photo 10: Units 1 & 2 Bottom Ash Ponds: west cell, view of over-steepened slope at downstream toe near northwest corner, most likely caused by excavation for pipe alignment adjacent to toe.

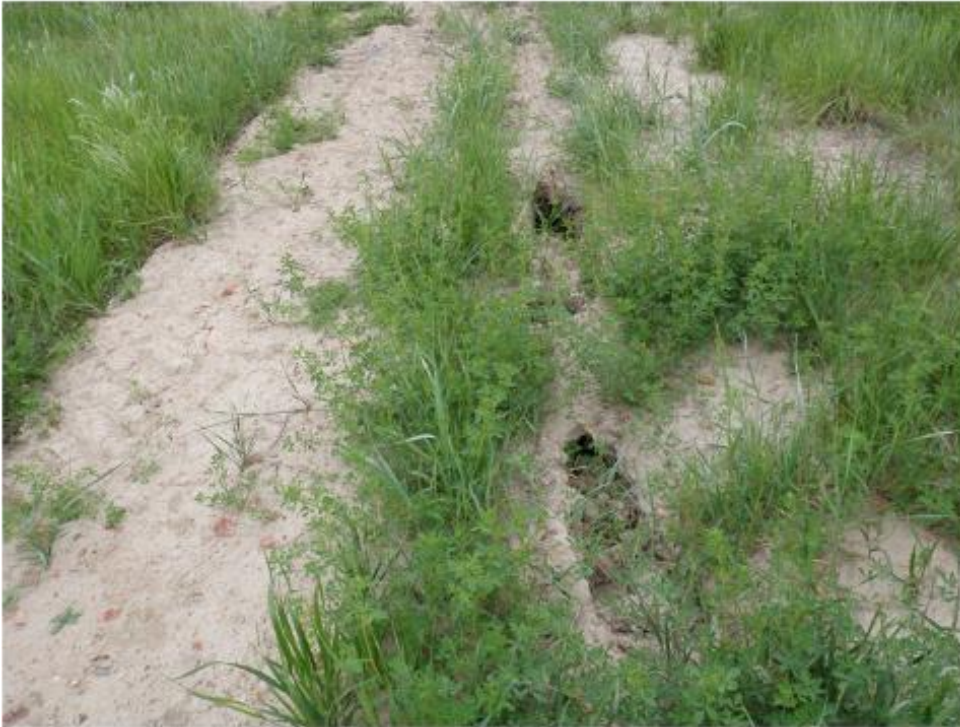
Photo 11: Units 1 & 2 Bottom Ash Ponds: west cell, view of settlement holes near northwest corner caused by poor compaction of pipe trench backfill. Similar holes were found along the entire toe of the Bottom Ash and "A" Pond embankments.

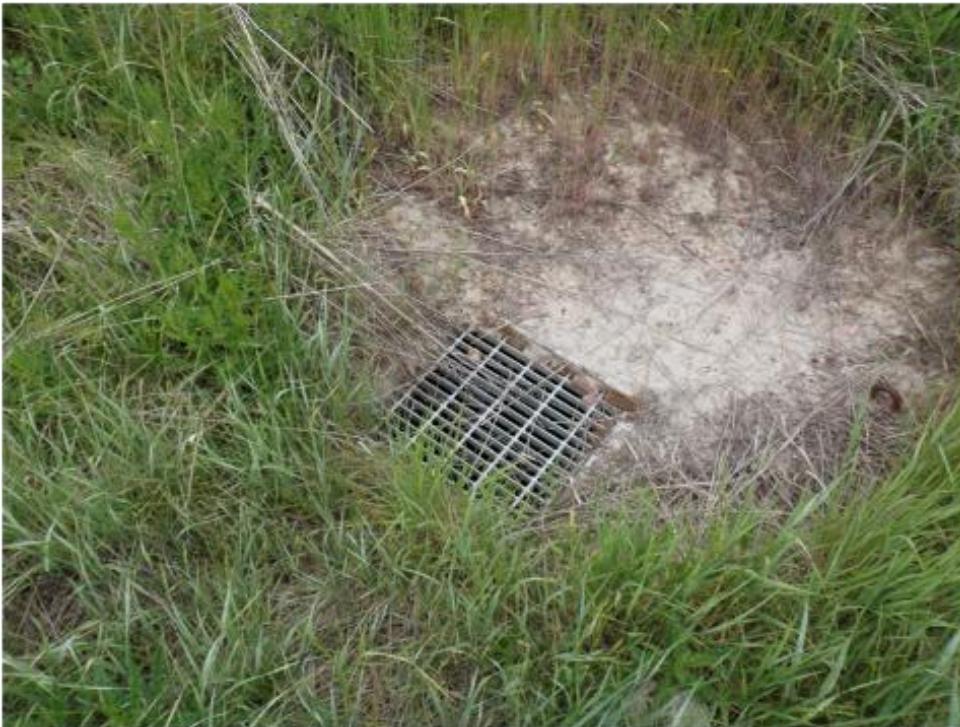
Photo 12: Units 1 & 2 Bottom Ash Ponds: west cell, view of out-of-service manhole at northwest corner. Manhole is about 20 feet deep.

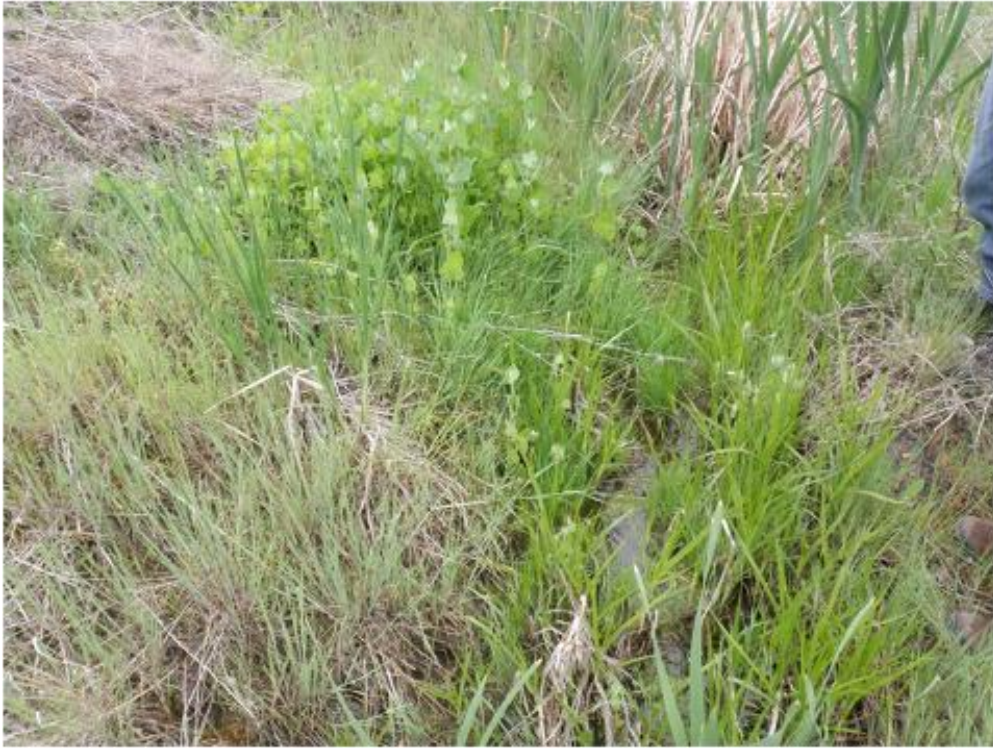
Evidence of seepage (standing water with vegetation) was observed near the northeast corner of the east cell of the Bottom Ash Ponds (Photo 13). The ponded water was at the downstream toe of the east embankment and has been active for a long period based on the locally dense stand of grass. A box culvert that penetrates the embankment near the crest is the likely seepage pathway. The water level of the east cell was observed to be at the invert of the box culvert. The east cell has a clay lining. The box culvert enables discharge pipes to

Photo 13: Units 1 & 2 Bottom Ash Ponds: east cell, view of poned seepage water at downstream toe near northeast corner of east cell. Seepage results from flow through box culvert that penetrates embankment crest.

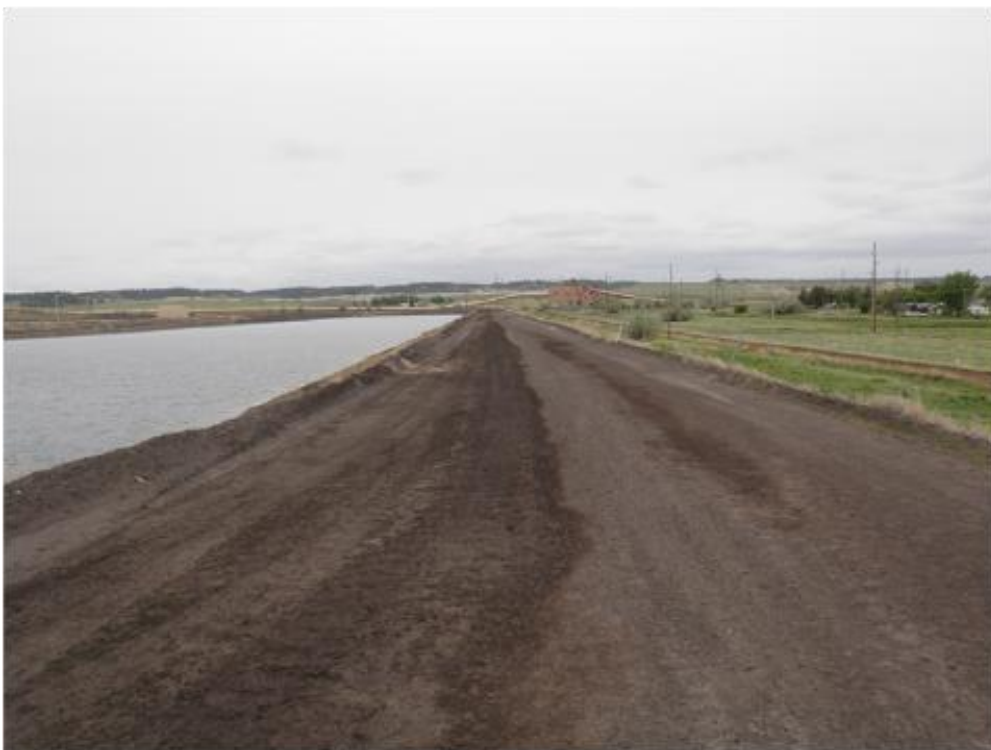
The embankment crest appeared to be in good condition. No signs of cracking or settlement were observed during the assessment. No vegetation was observed on the dam crest (Photo 15).

Photo 15: Units 1 & 2 "A" Pond: View from northwest corner, looking south at upstream slope and crest of clay lined pond.

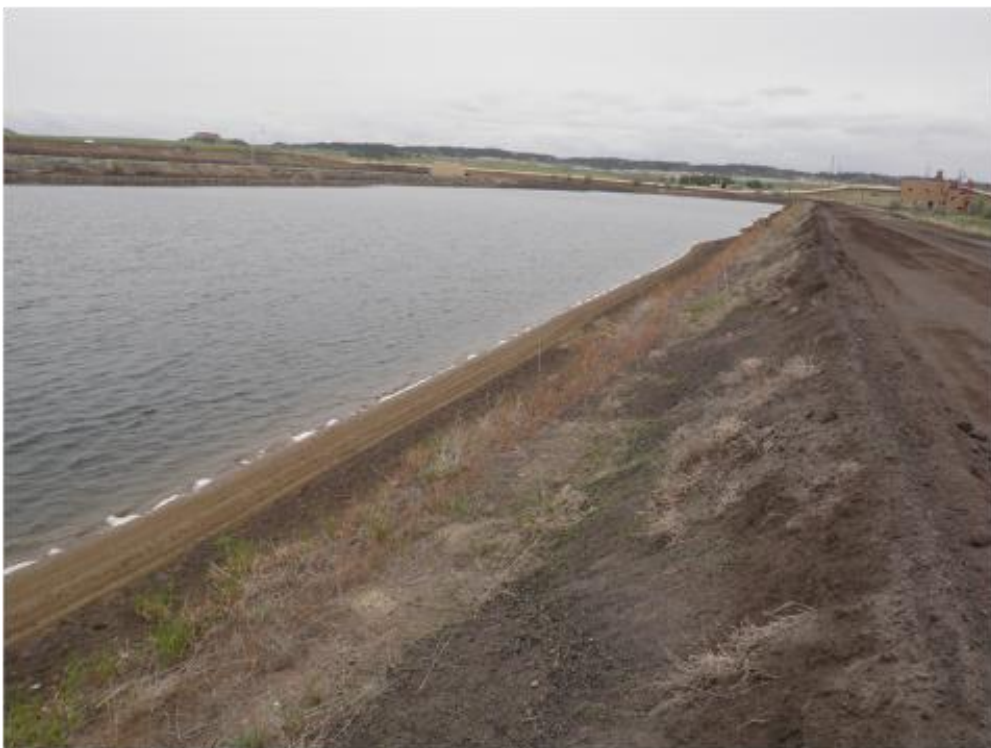
Photo 16: Units 1 & 2 "A" Pond: looking south at upstream slope of west embankment. Note minor vegetation.

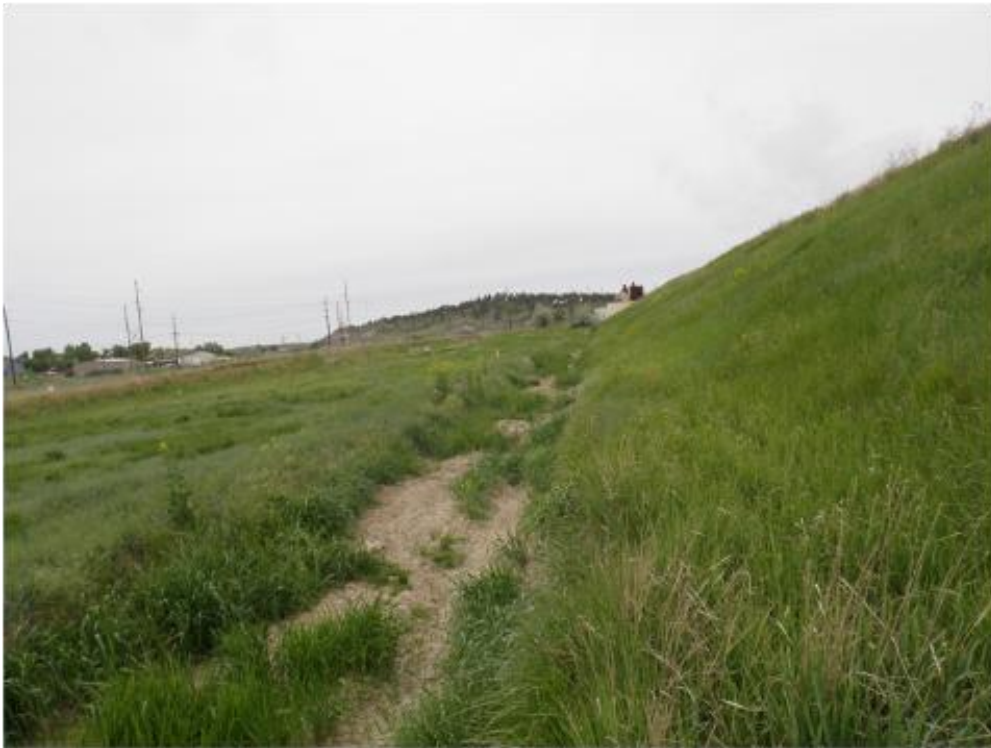
Photo 17: Units 1 & 2 "A" Pond: looking north at downstream toe and slope of west embankment. Note disturbed soil of pipe trench backfill along toe.

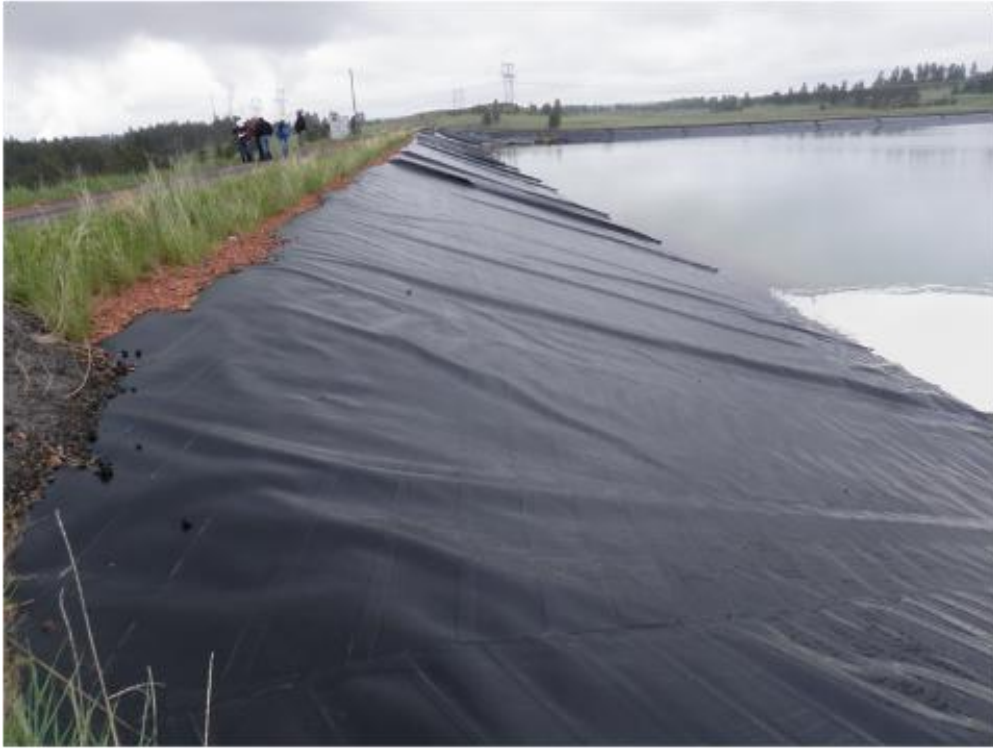
Photo 21: Units 1 & 2 STEP Dam – upstream slope at clearwell, looking to right. Note RFP liner in good condition and slope appears uniform and regular.

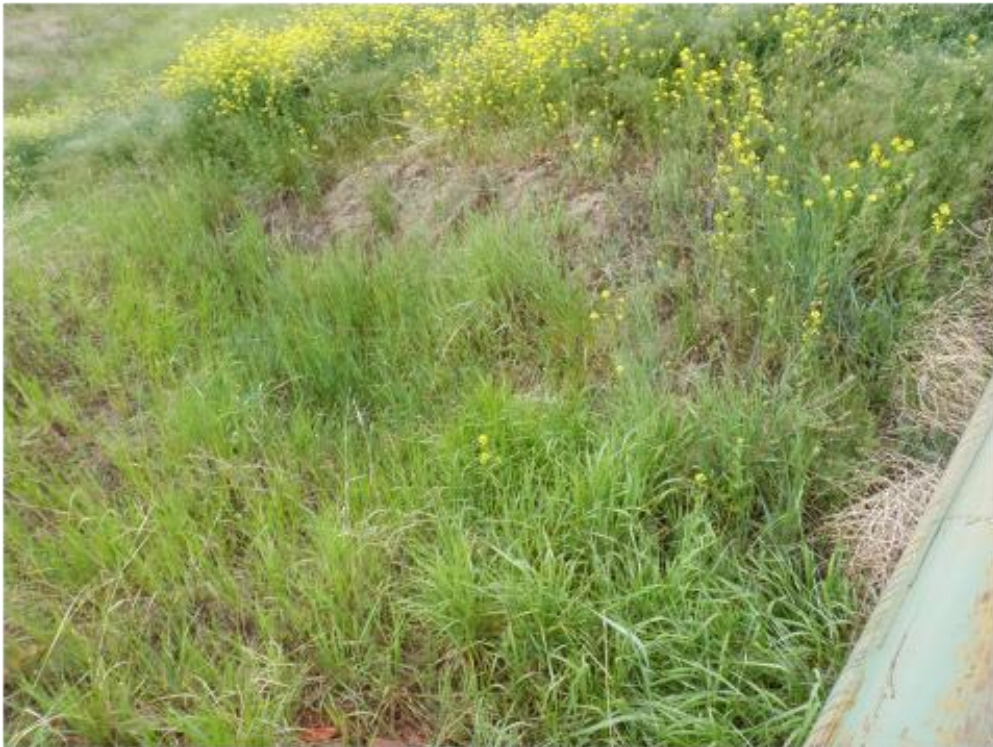
Photo 22: Units 1 & 2 STEP Dam: erosion on upstream slope due to surface water run-on near groin at right abutment.

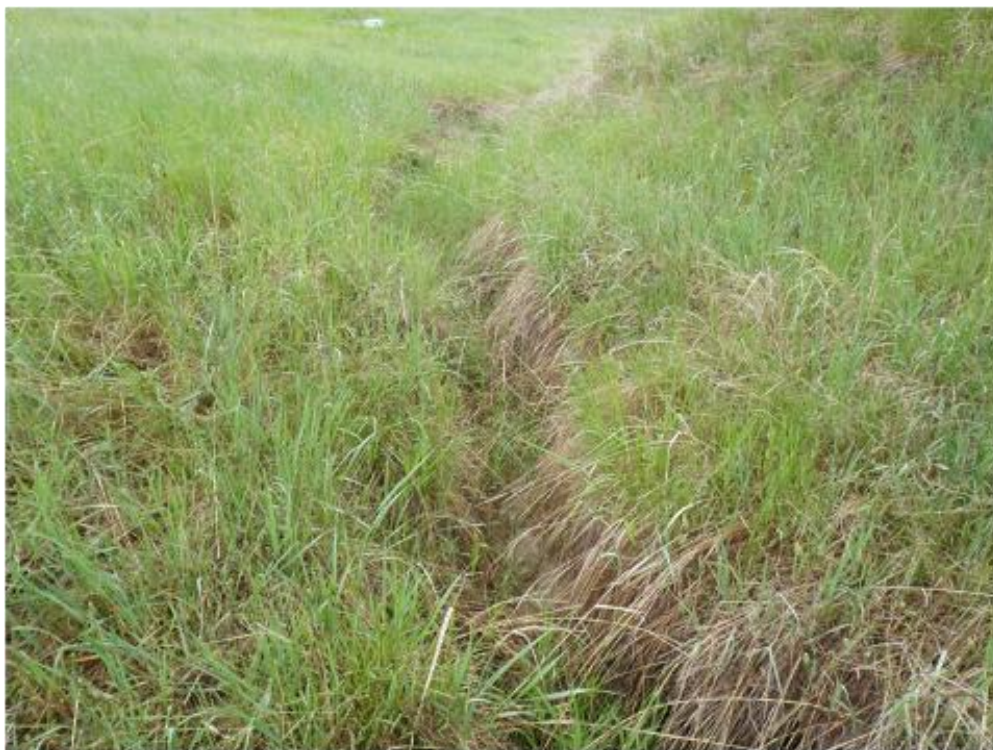
Photo 25: Units 1 & 2 STEP Dam: erosion in groin near right downstream groin caused by stormwater runoff from a drainage area located to the right of the dam.

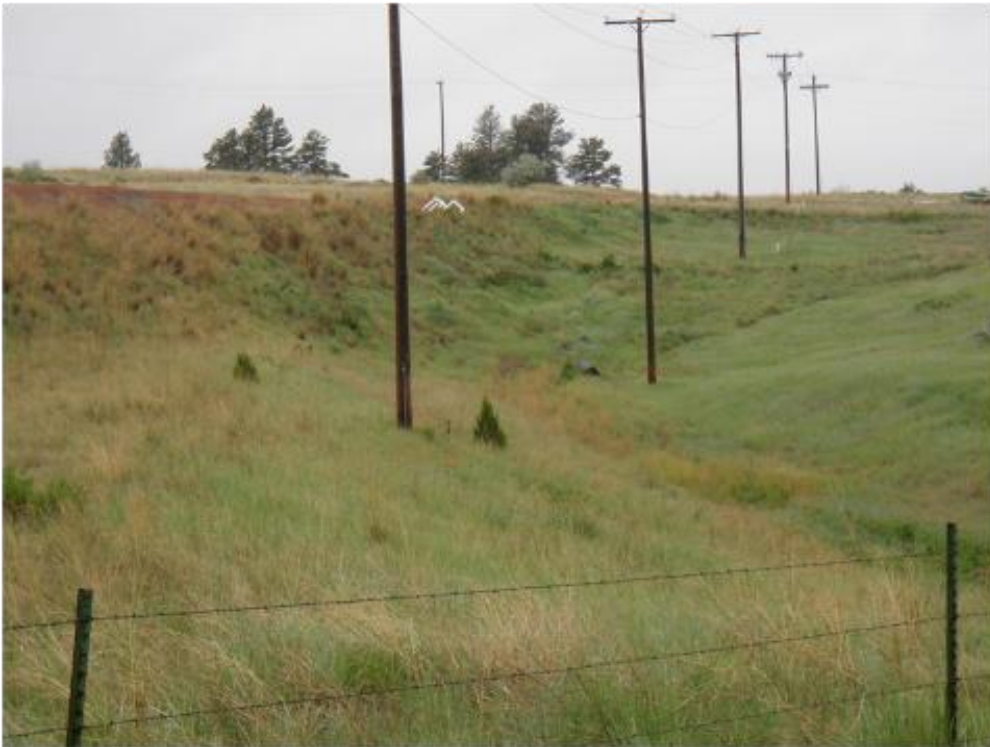
Photo 28: Units 3 & 4 Main Dam: Fill in topographic low area (saddle) located about 500 feet to the left of left abutment. This fill may constitute part of the Main Dam, but has not been documented as such.

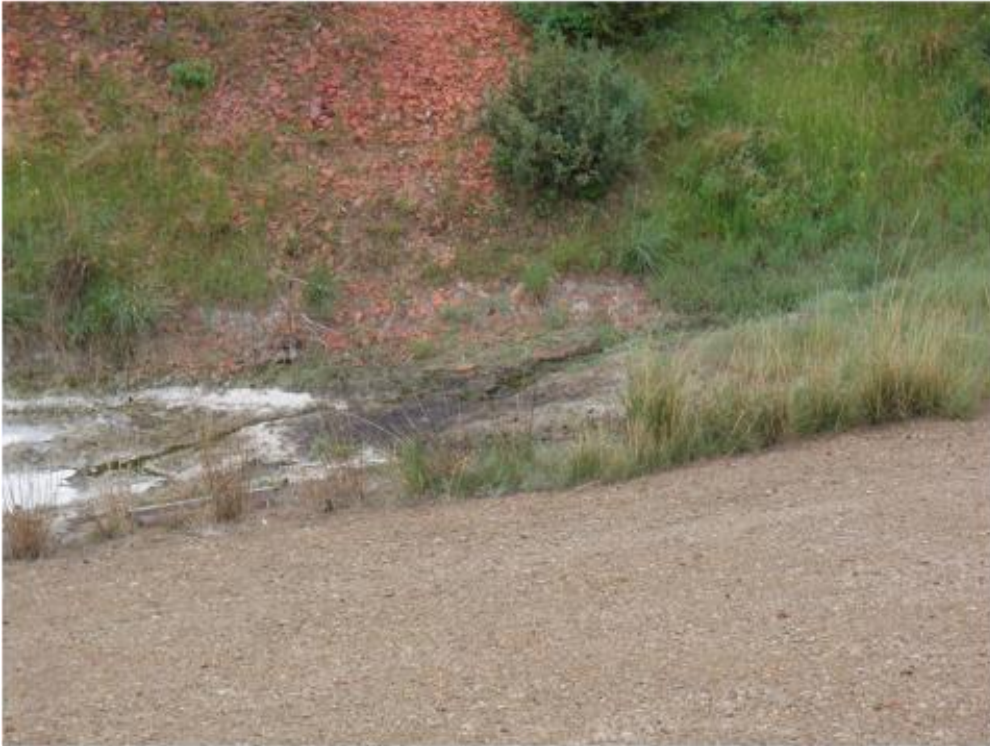
Photo 31: Units 3 & 4 Main Dam: seepage at left abutment on upstream face. Seep is above the reservoir elevation and apparently originates from perched water in adjacent divider berm or in abutment.

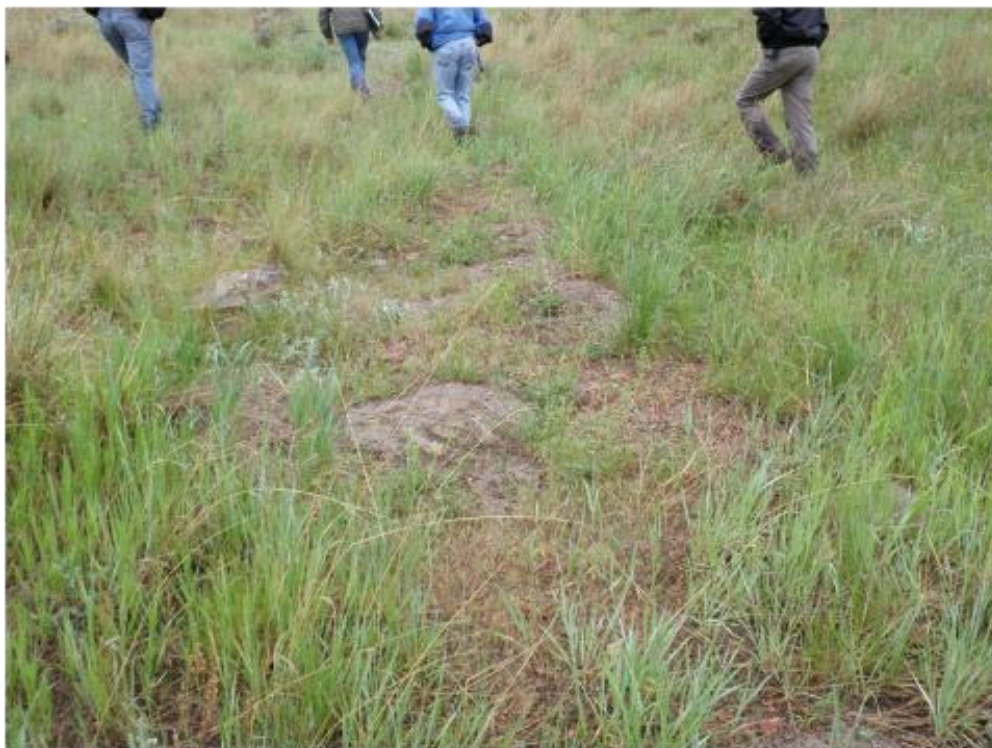
Photo 34: Units 3 & 4 Main Dam: Drain sand exposed by rodent activity in right groin drain system.

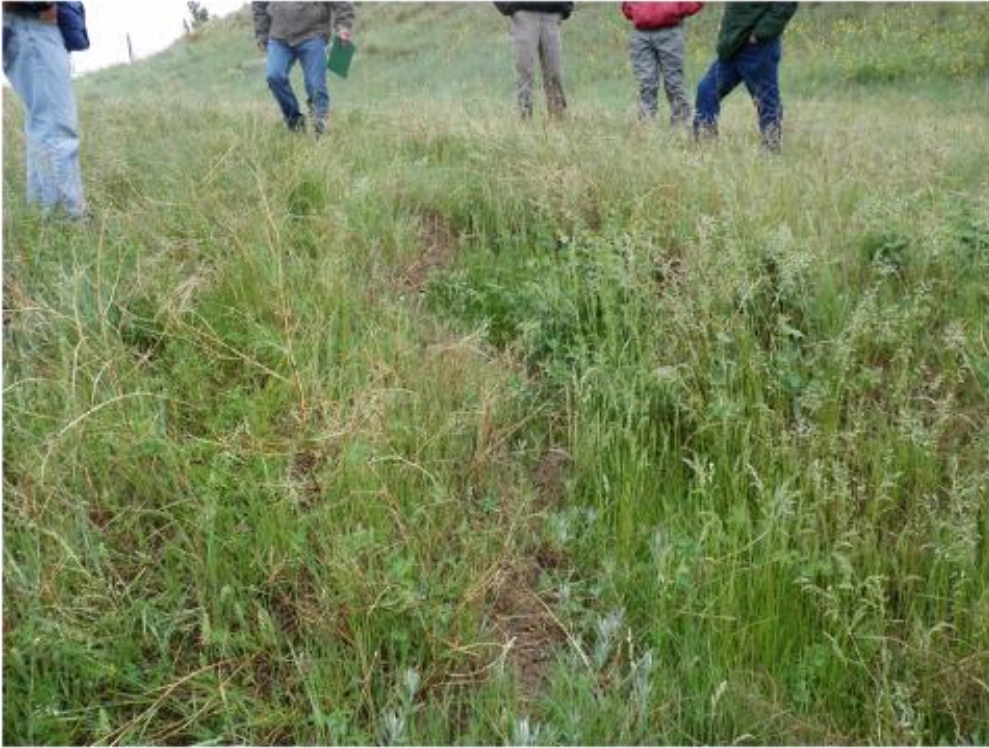
Photo 35: Units 3 & 4 Main dam: Minor surface erosion at about mid-height on downstream slope near left groin.

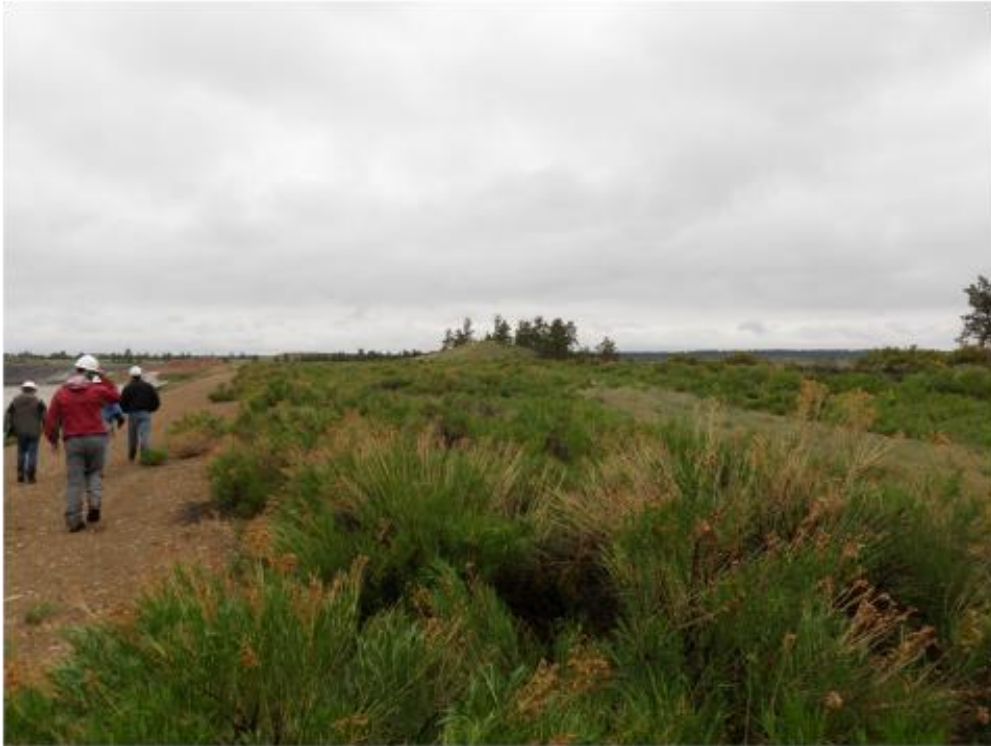
Photo 37: Units 3 & 4 Saddle Dam: Upstream side of upstream crest at right abutment. Note heavy sage brush vegetation.

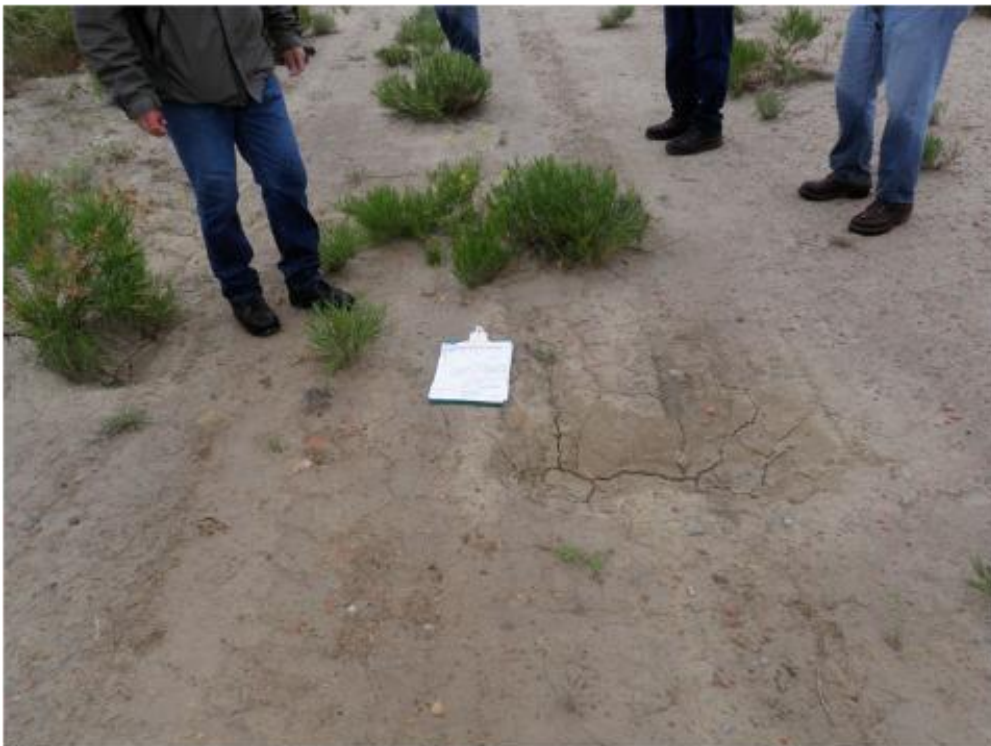
Photo 38: Units 3 & 4 Saddle Dam: Healed/infilled cracks on crest (originally observed in association with the 1999 seepage event). Cracks are aligned with the upstream side of the concrete cutoff wall.

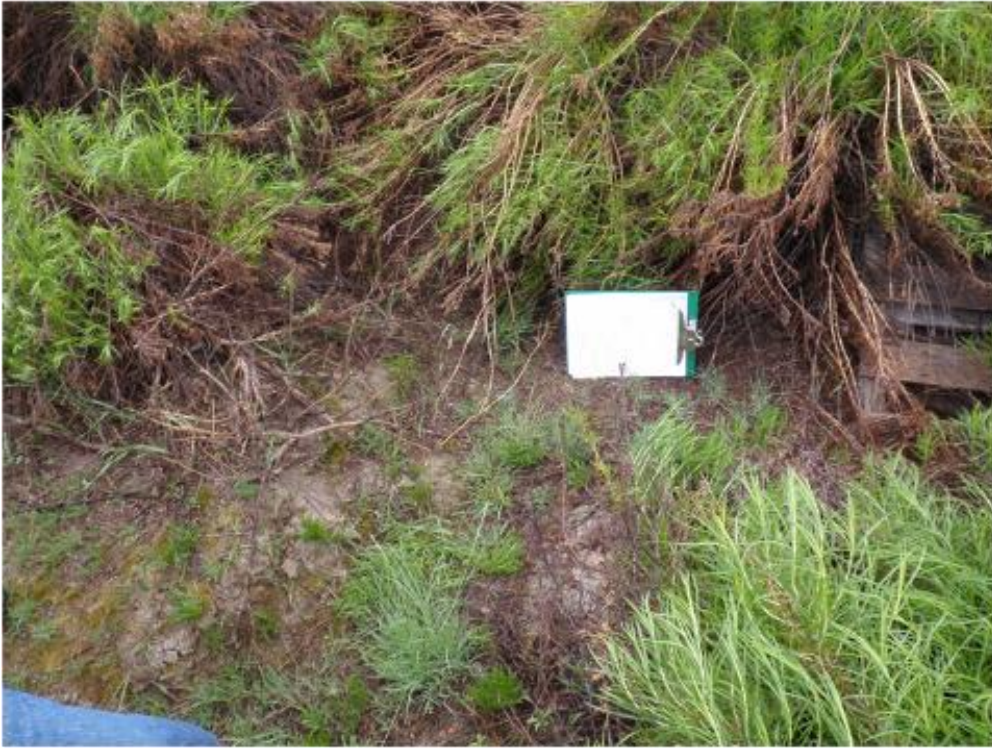
Photo 39: Units 3 & 4 Saddle Dam: Healed/infilled crack on crest (originally observed in 1999 – up to 1 foot wide and several feet deep).

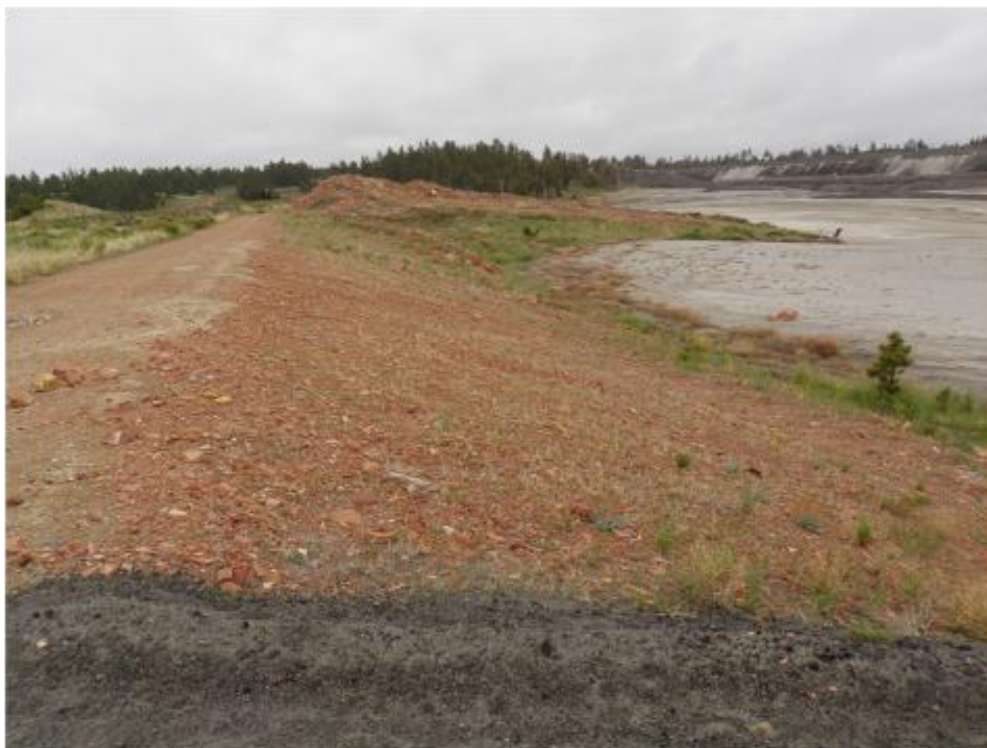
Photo 41: Units 3 & 4 Saddle Dam: Upstream face near mid-point along dam length and near intersection with "G" cell divider dike. Note minor vegetation on soil cement.

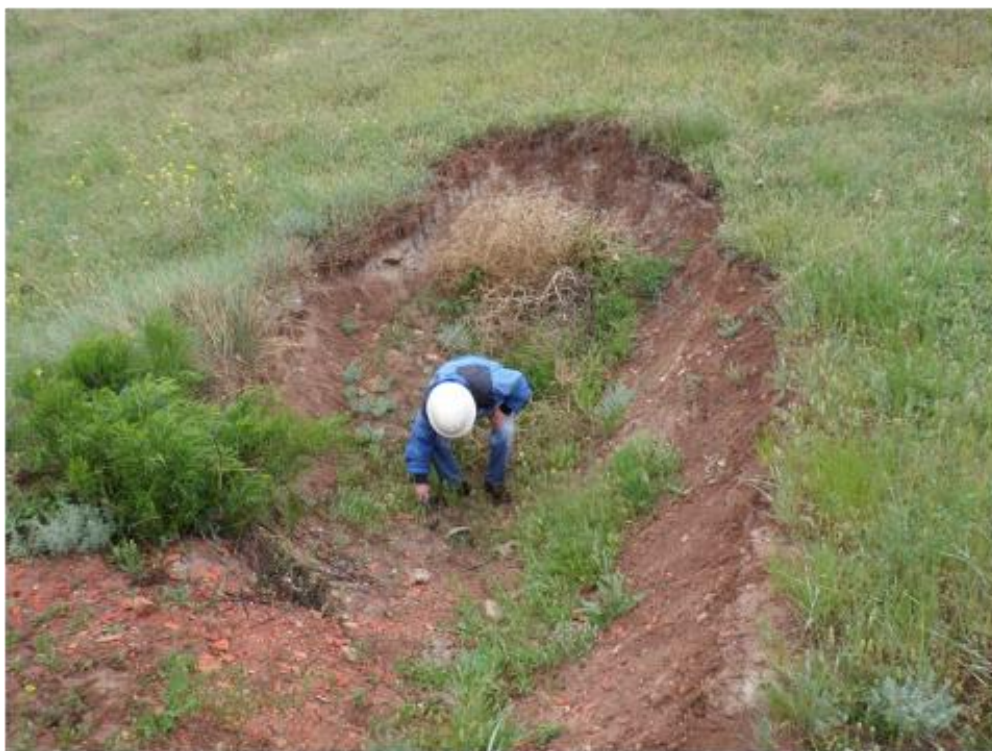
Photo 44: Units 3 & 4 Saddle Dam: Test pit excavated in 1999 that has not been backfilled. Granular drain material and broken toe drain pipe was exposed in the test pit.

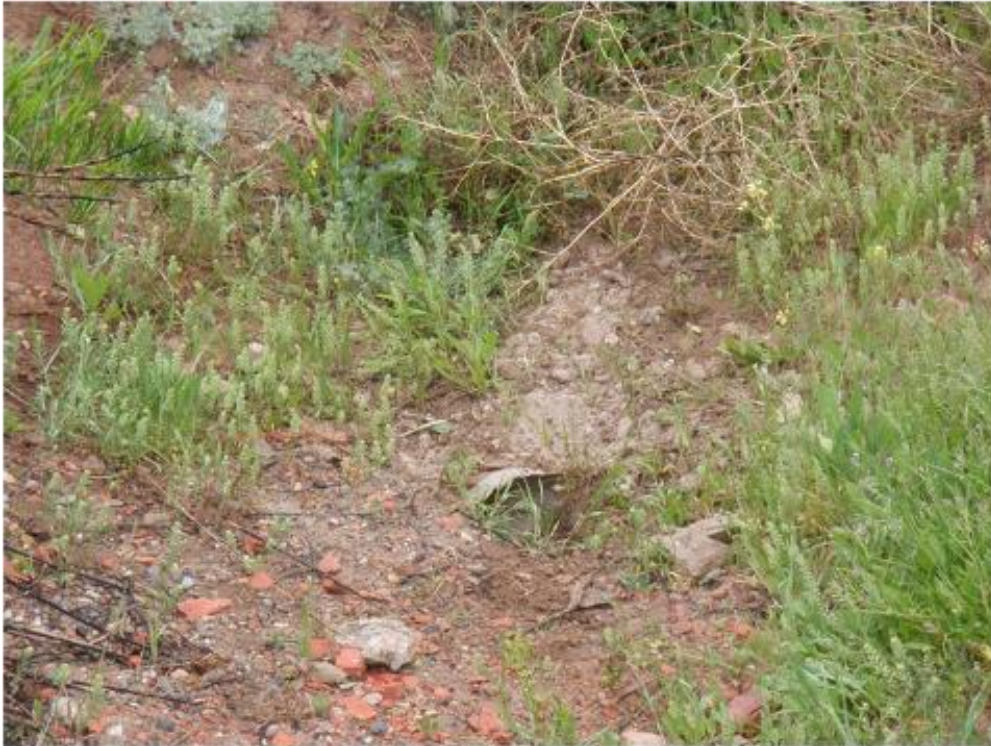
Photo 45: Units 3 & 4 Saddle Dam: Close-up view of drain sand and drain pipe in test pit.

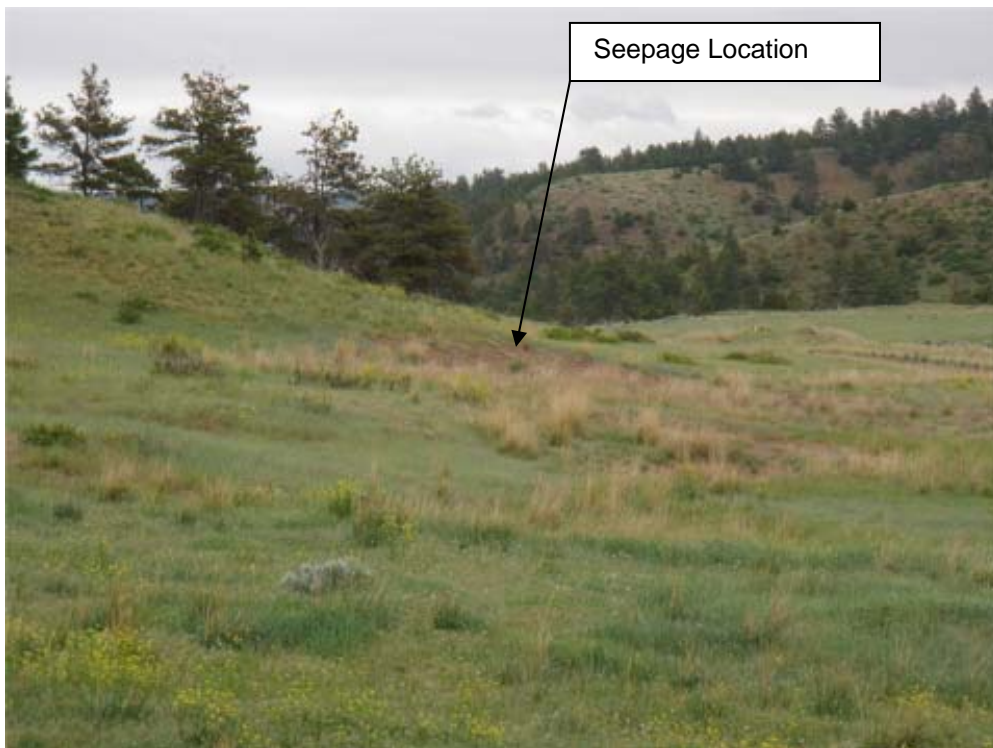
Photo 47: Units 3 & 4 Saddle Dam: Looking directly downstream at location where the 1999 seepage day-lighted near base of the rock hill. The bare ground marks the seepage location, which is about 100 yards downstream of the dam toe.
